LITTLE RIVER LOWER DAM
ME 00288

PHASE I INSPECTION REPORT
NATIONAL DAM INSPECTION PROGRAM

NOVEMBER 1979

Identification No.: ME00288
Name of Dam: Little River Lower Dam
Town: Belfast
County and State: Waldo, Maine
Stream: Little River
Date of Inspection: September 17, 1979

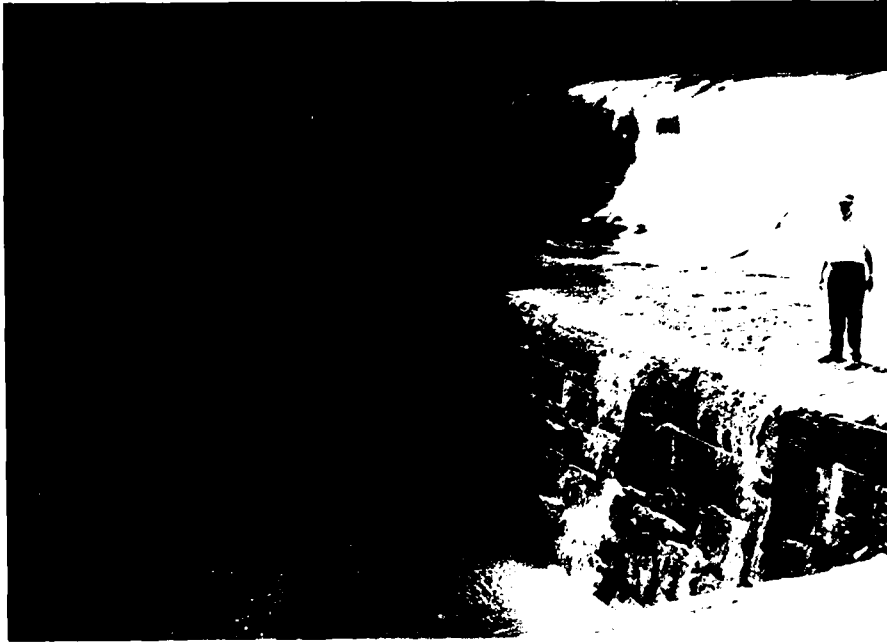
September 17, 1979
Figure 2 - Downstream face of the dam.

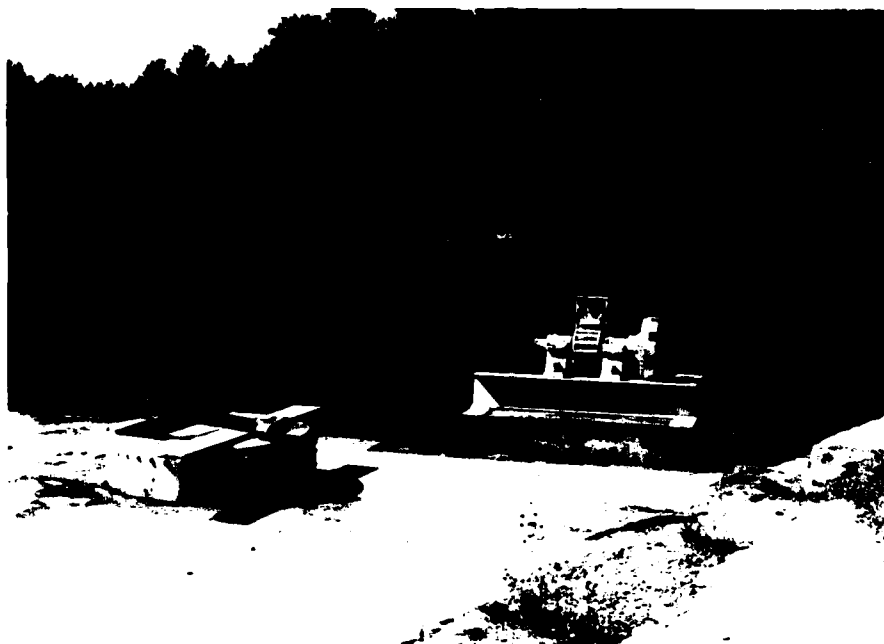
b. Mechanical and Electrical	
Air Vents	Gate operating mechanism is in poor condition-no indication of maintenance, lubrication or operation. Belfast Water District Superintendent indicated that gate hasn't been operated in 24 years.
Float Wells	
Crane Hoist	
Elevator	
Hydraulic System	None
Service Gates	Not visible-reported to be steel
Emergency Gates	None
Lightning Protection System	None
Emergency Power System	None
Wiring and Lighting System	Not applicable

September 17, 1979
Figure 4 - Gate mechanism at the north abutment.

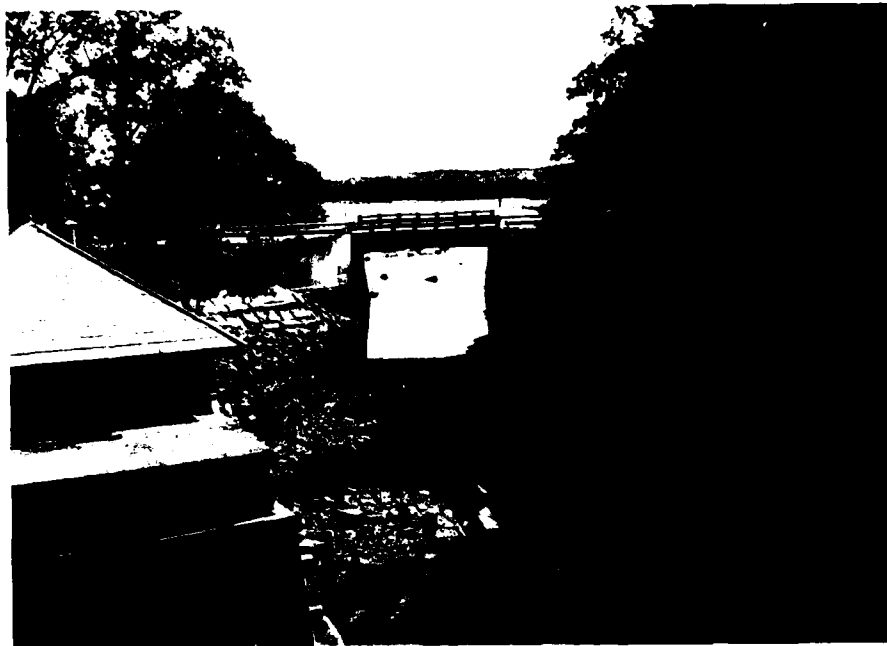
September 17, 1979
 Figure 12 - Looking downstream at U.S. Route 1 bridge
 from the north abutment of the dam.
